**NAVAL AIR STATION
SIGONELLA
(AUGUSTA BAY)
FLEET MOORING
UNDERWATER
INSPECTION
REPORT**

NOVEMBER 1983

OCEAN ENGINEERING
AND CONSTRUCTION PROJECT OFFICE
CHESAPEAKE DIVISION
NAVAL FACILITIES ENGINEERING COMMAND
WASHINGTON, D.C. 20374

FPO-1-83 (45)

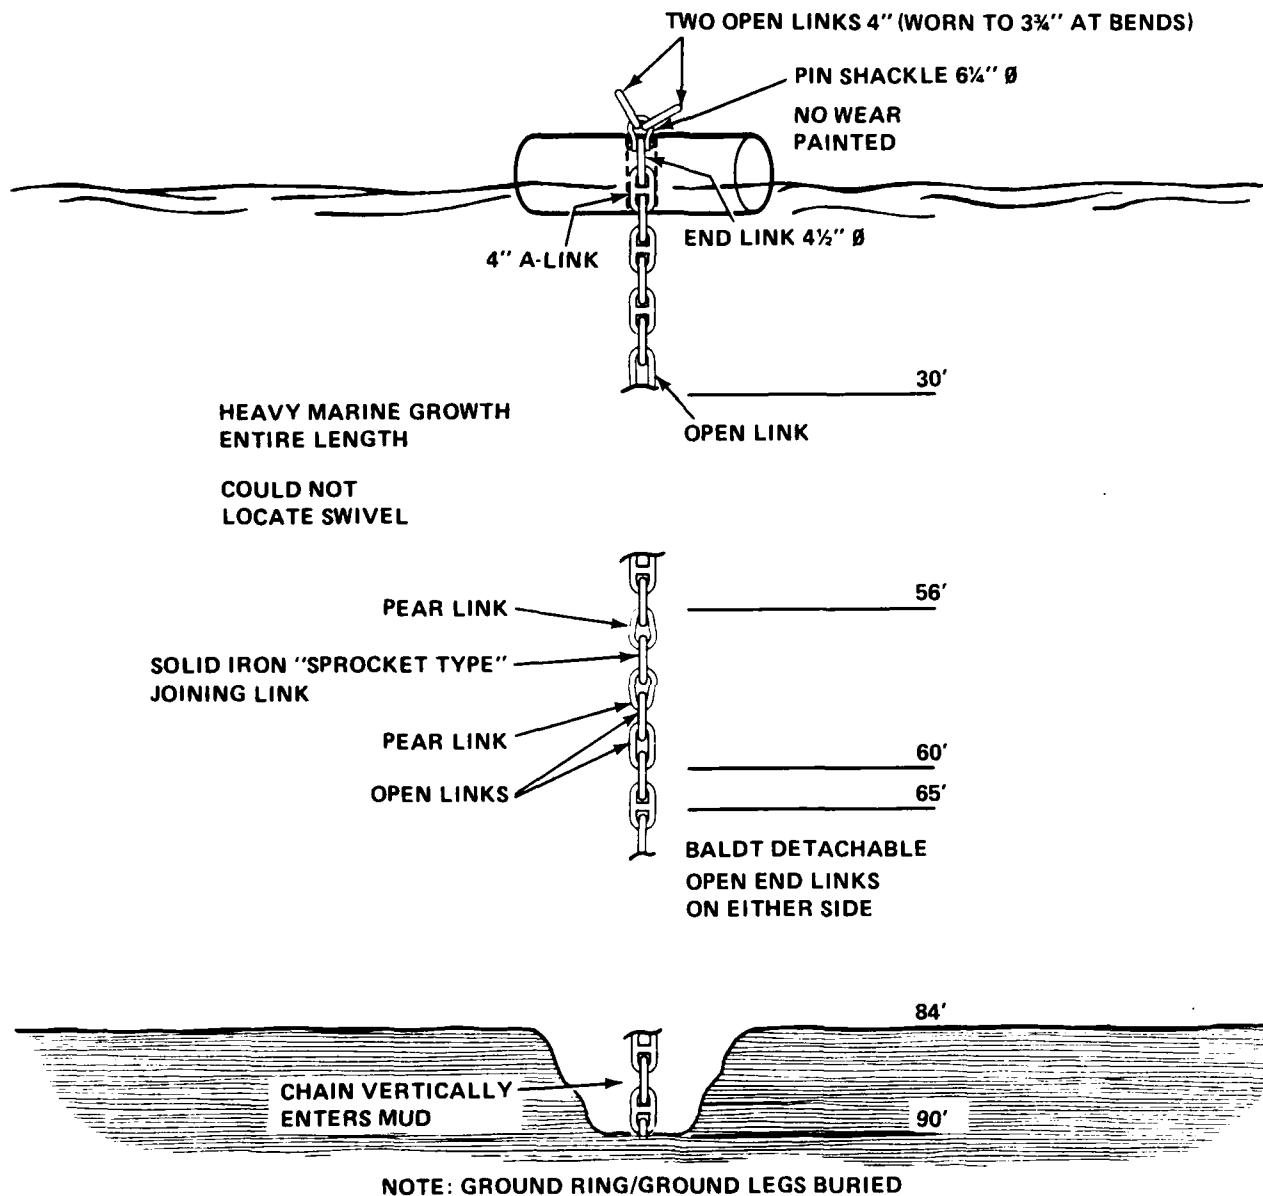
FIGURE 4. MOORING A-3 AS-BUILT CONFIGURATION

This is a 7-foot diameter, 13-foot long cylindrical-type buoy with a hawsepipe. The buoy is painted and shows no sign of damage. The top jewelry is painted and shows no evidence of usage. The fenders are in good condition.

The riser is heavily encrusted with marine growth. Several areas were cleaned and double link measurements taken. The riser consists of various sizes of chain and accessories all of which were larger than the 3 1/2 inches required for a class CC mooring. Sizes ranged from 3 5/8 inches to 4 1/8 inches and all measurements were greater than 90 percent of the links' original wire diameter. The riser swivel was not located but could be hidden beneath the heavy mussel growth. The riser drops vertically into the bottom.

On the basis of the good condition of the buoy and riser chain, this mooring is considered to be in satisfactory condition for continued use as a CC class mooring.

- o Due to lack of usage, the requirement to operate and maintain this mooring should be reviewed.
- o The mooring is in satisfactory condition for continued use as a class CC mooring.
